CHAPTER D-7 FOUNDATION RISKS FOR CONCRETE DAMS

D-7.1 Key Concepts

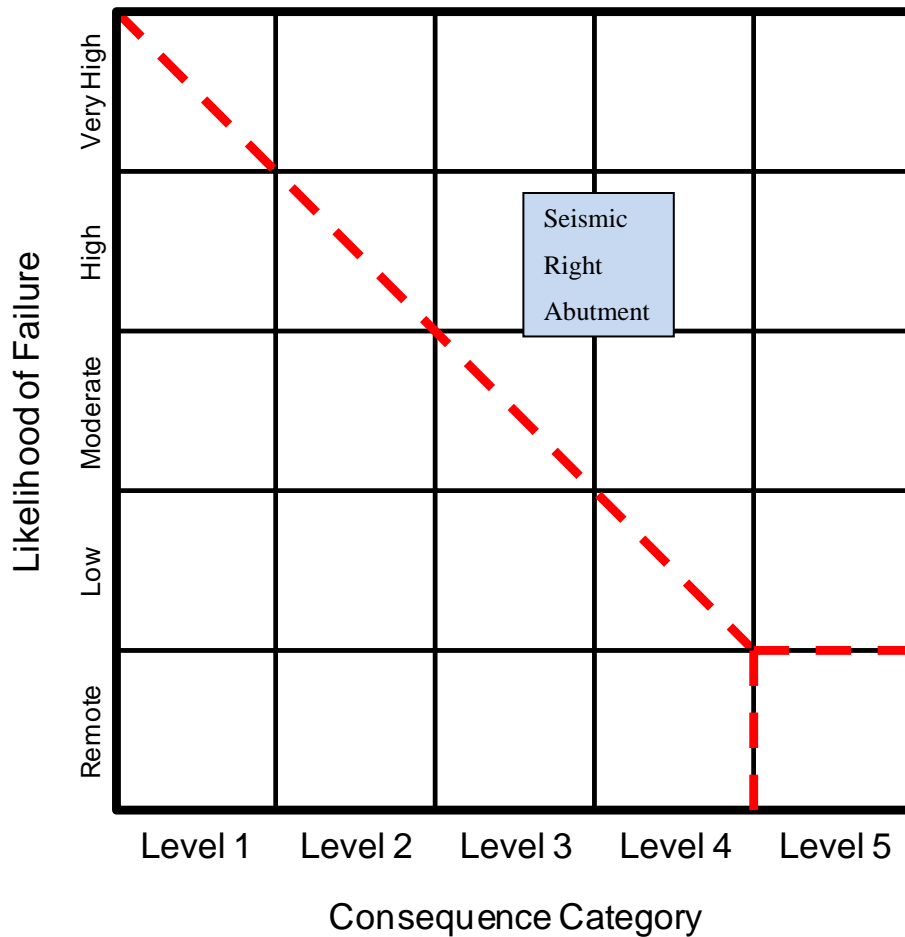
This semi-quantitative evaluation plots on the risk matrix as shown in Figure D-7-21. Based on the fact that the risks plot with high confidence in an area on the matrix where they may justify action, a quantitative analysis of risk for this potential failure mode can be justified. Given the detailed description of the potential failure mode, an event tree can be constructed as shown in Figure D-7-22. Only one seismic load branch (1/10,000 to 1/25,000 annual exceedance probability) is constructed all the way through the event tree for illustration purposes. The conditional failure probability branches following the load branch must be duplicated for all load ranges above the threshold load value. The probability of failure is dependent on not only the earthquake loading level, but also the reservoir level at the time the earthquake hits. If several reservoir and earthquake levels were represented in the tree, it would be extremely large. To simplify the evaluation, only one reservoir load range was included, chosen to represent loadings which were significant to the abutment wedge and at levels that would produce significant consequences if failure occurred. The event tree was developed after a credible foundation wedge had been defined based on a detailed evaluation, and the primary geologic uncertainty is the joint continuity. Uncertainties related to joint orientation, strength, and water forces for a given uplift condition do not necessarily follow linearly, are interrelated, and all affect the stability. These were handled in external kinematic stability analyses as discussed below.

Figure D-7-21 Risk Matrix

Comparing Figure D-7-24 with Figure D-7-21 indicates that the risks are estimated to be slightly lower from the detailed quantitative risk analysis in comparison to the semi-quantitative screening. Although the consequences category was a reasonable reflection of the detailed evaluation, the likelihood category was about half an order of magnitude higher than the quantitative estimates.

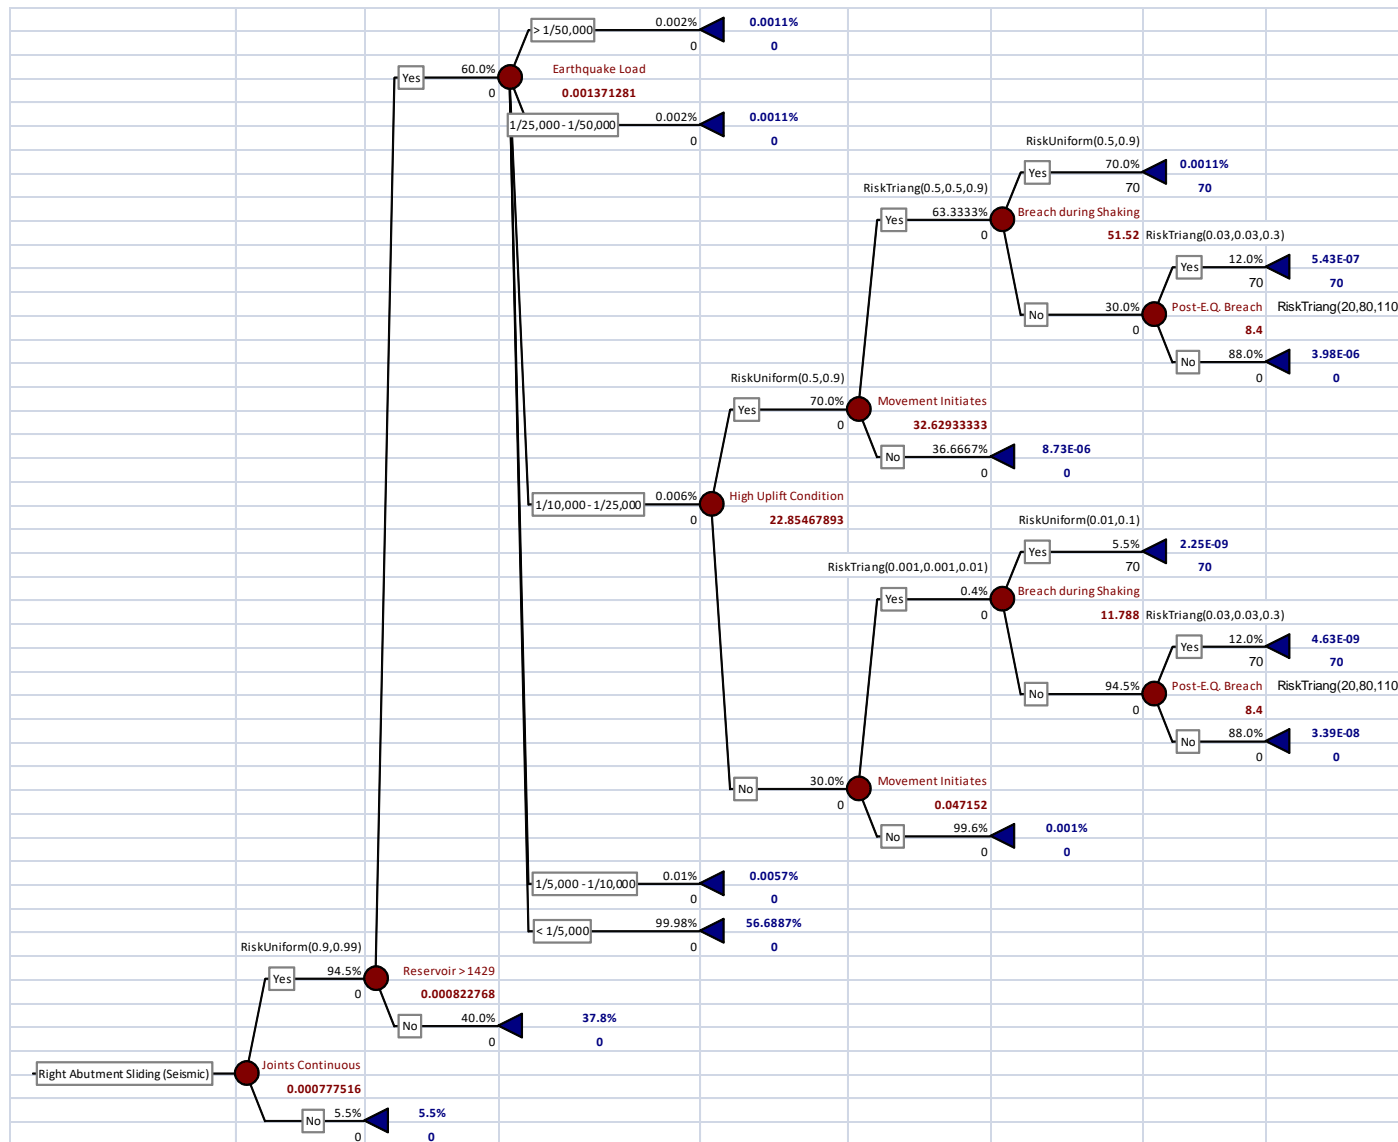
Figure D-7-22 Example Event Tree

Monte-Carlo simulation results developed from the event tree shown in Figure D-7-22 are depicted in the scatter-plot shown in Figure D-7-24, where each point represents a single combination of possible values chosen from each variable's probability distribution. The mean (shown by the large open circle) represents the 'expected value' of the risk estimates (where the weighted consequences are typically calculated as the annualized life loss divided by the annualized failure probability). The outlying points represent situations where more extreme values are chosen from each variable's probability distribution. The likelihood of and extent to which the variation in results exceed the risk guidelines (in this case Reclamation's guidelines shown) can be an important input to the decision process.

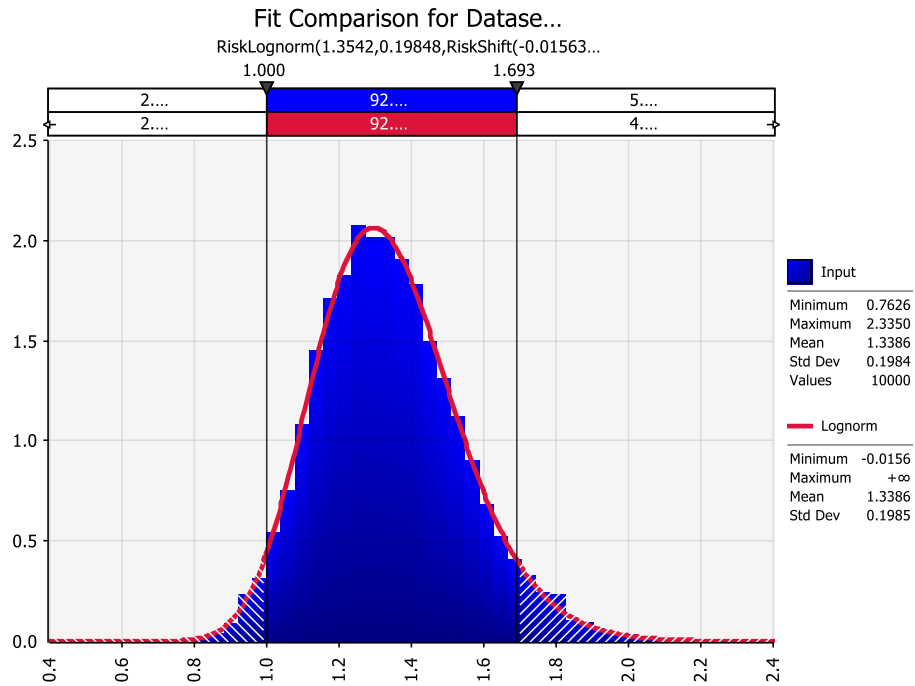
Figure D-7-23 Output from Monte Carlo Simulation (horizontal axis is factor of safety)

The weight of the wedge was varied in the analysis using a uniform distribution (equally likely between lower and upper input values) considering reasonable variations in unit weight and wedge volume. The water forces are also uncertain, but for post-earthquake conditions it was assumed the joints opened sufficiently to generate full hydrostatic loading on the back release joint, varying linearly to the “daylight” trace of the side and base plane joints downstream. The post-earthquake thrust from the arch dam, although uncertain, was taken as constant for a high reservoir elevation, based on finite element structural analyses simulating post-earthquake conditions to the extent possible. The results of 10,000 iterations in terms of sliding factor of safety are shown in Figure D-7-23. As can be seen, approximately 2.9 percent of the calculated factors of safety were less than 1.0 (i.e. probability of $FS < 1.0 = 0.029$).

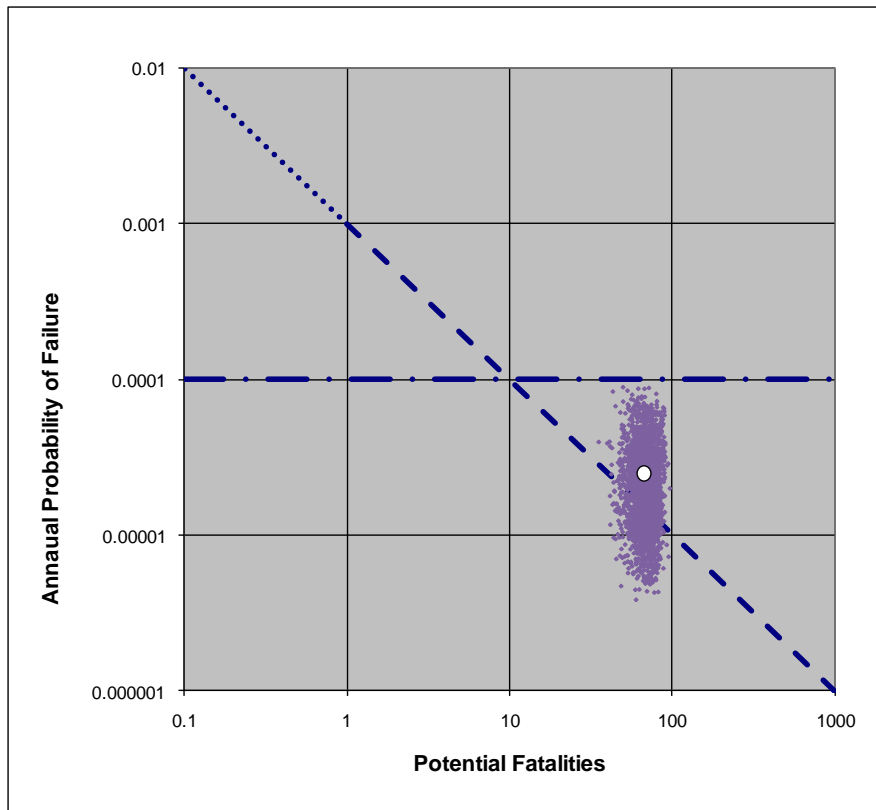
Figure D-7-24 Scatter Plot from Event Tree Monte-Carlo Analysis
